LEVEL ONE

SURVEILLANCE

AND INSPECTION REPORT

Project Name: Ellery Estate, Stage 10

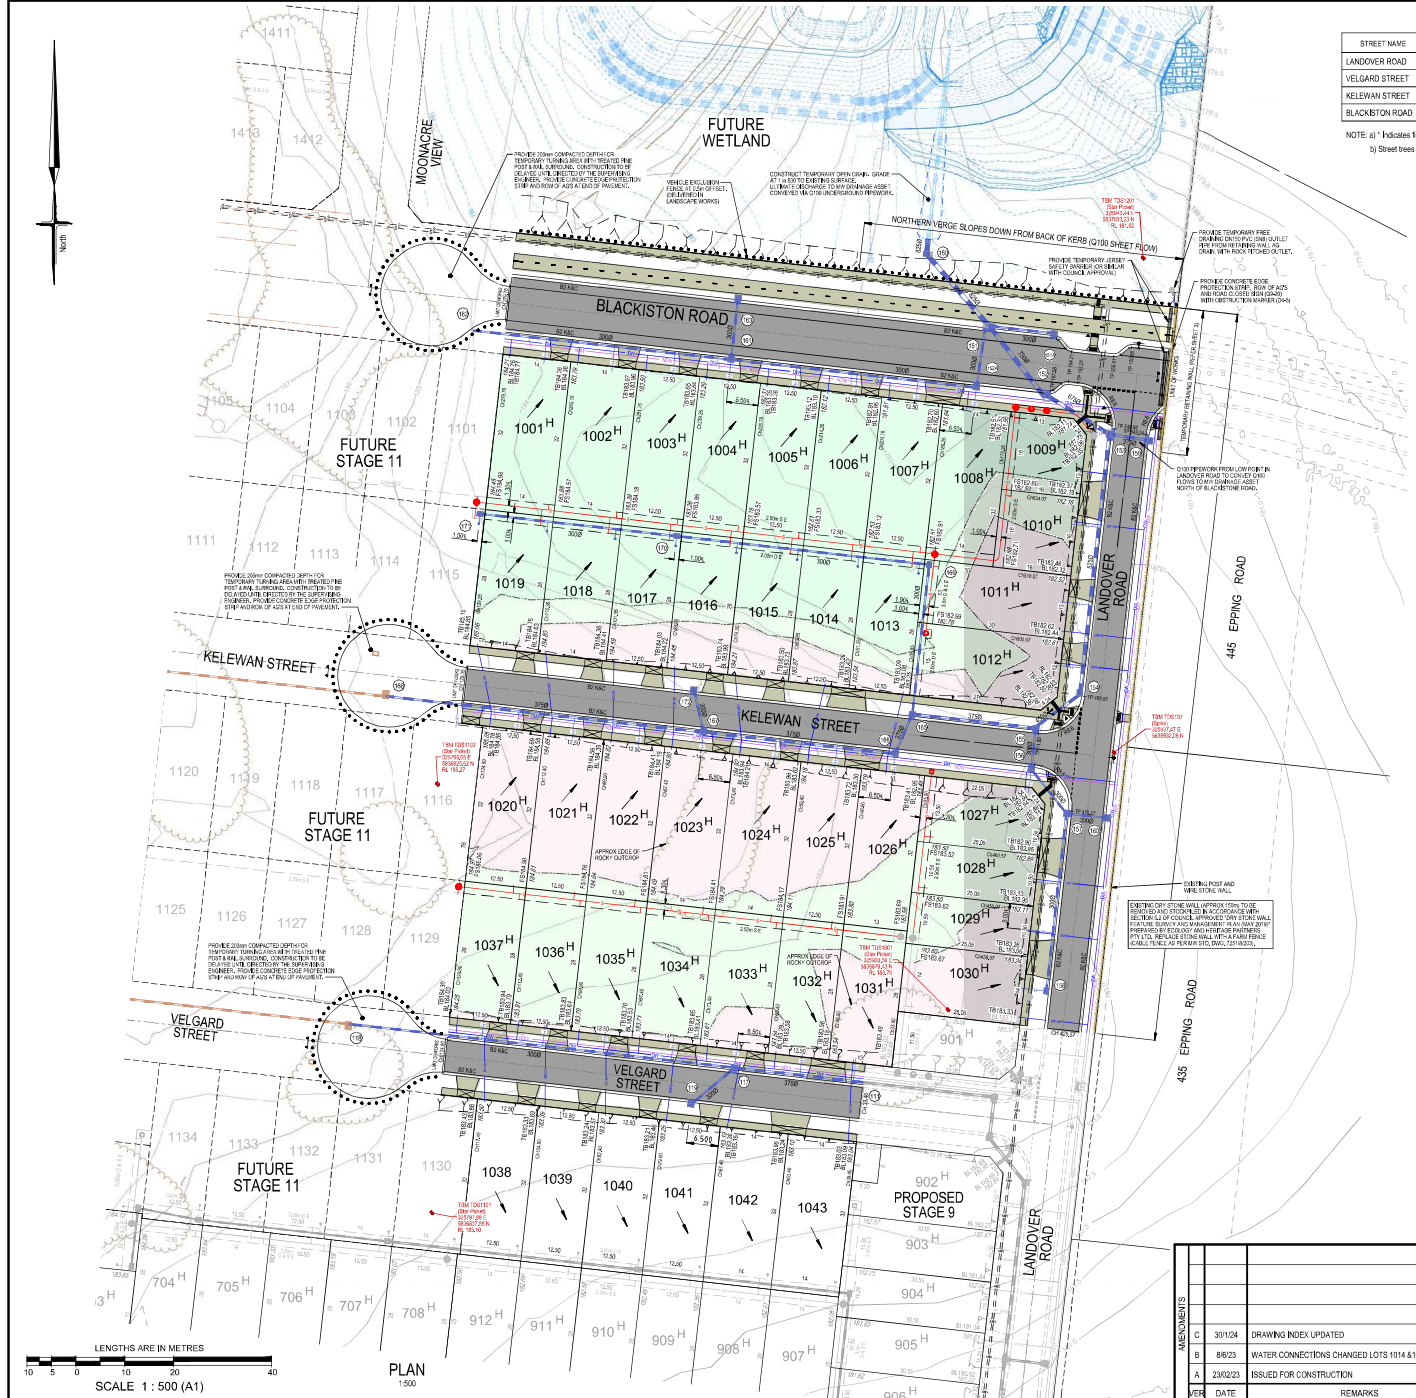
<b>breese pitt dixon pty. ltd.</b> land surveyors civil engineers		1/19 calo street hawthorn east, 3123, telephone 8823 2300 fax no. 8823 2310
MELWAY REF. 359-B10 SURVEY BPD DESIGN DG DRAWN DG		<b>ELLERY ESTATE</b> <b>STAGE 10</b> LAYOUT PLAN AND SERVICES SCHEDULE		MUNICIPALITY <b>WHITTLESEA</b> REFERENCE <b>8625 E/10</b>
AMENDMENTS C 30/1/24 DRAWING INDEX UPDATED B 8/6/23 WATER CONNECTIONS CHANGED LOTS 1014 & 1028 A 23/0/23 ISSUED FOR CONSTRUCTION	CHECKED C,HAGEN SCALE As Shown DATUM AHD DATE Jan'23	SHEET 1 OF 12		C

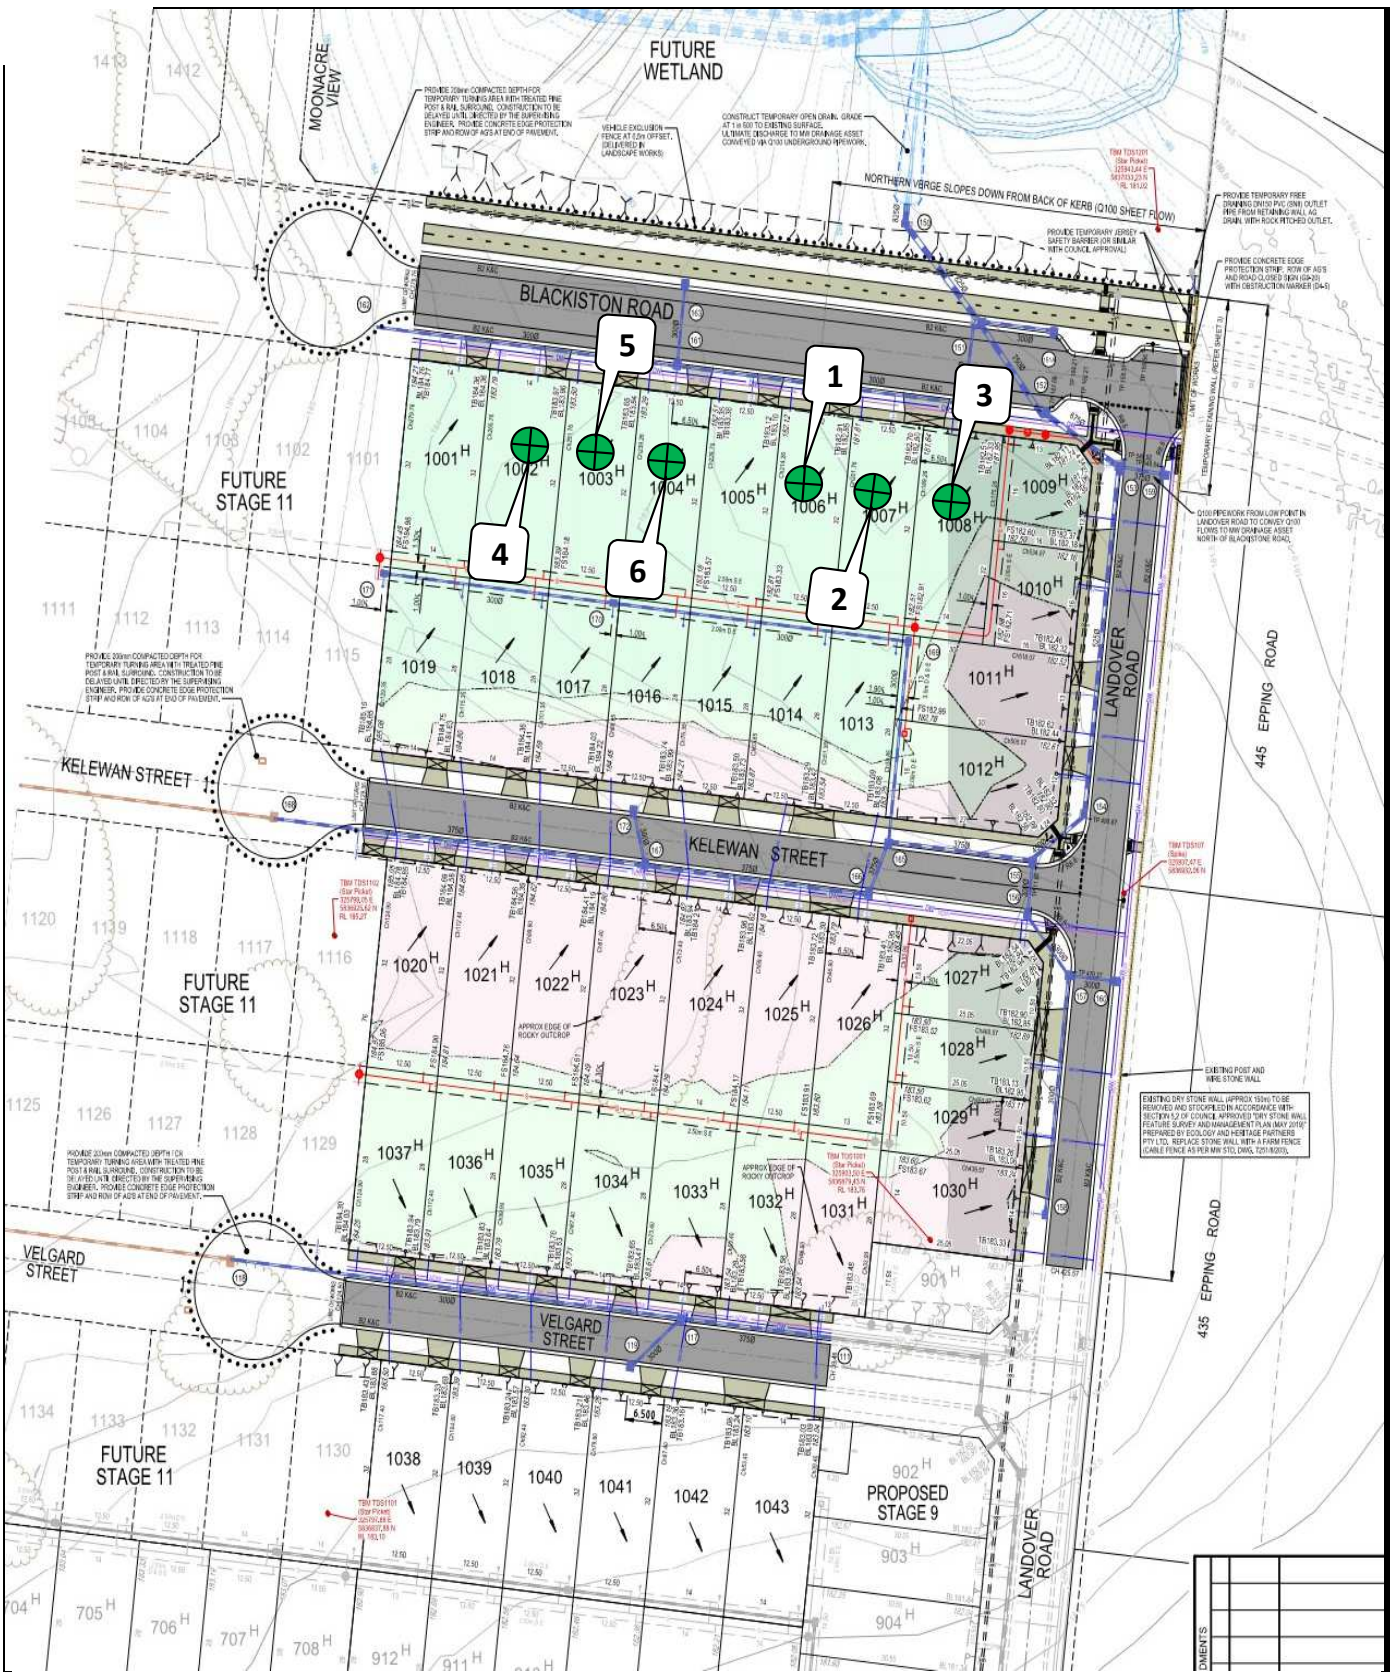
**JOB No.: 9189/008**  
**CHECKED: KK**  
**FIGURE No: -**

**CLIENT: SYMON BROS**  
**LOCATION: Ellery Estate, Stage 10**  
**Sketch indicating compaction test locations**

**DATE: 6/06/2024**  
**OPERATOR: SA**  
**SCALE: NTS**

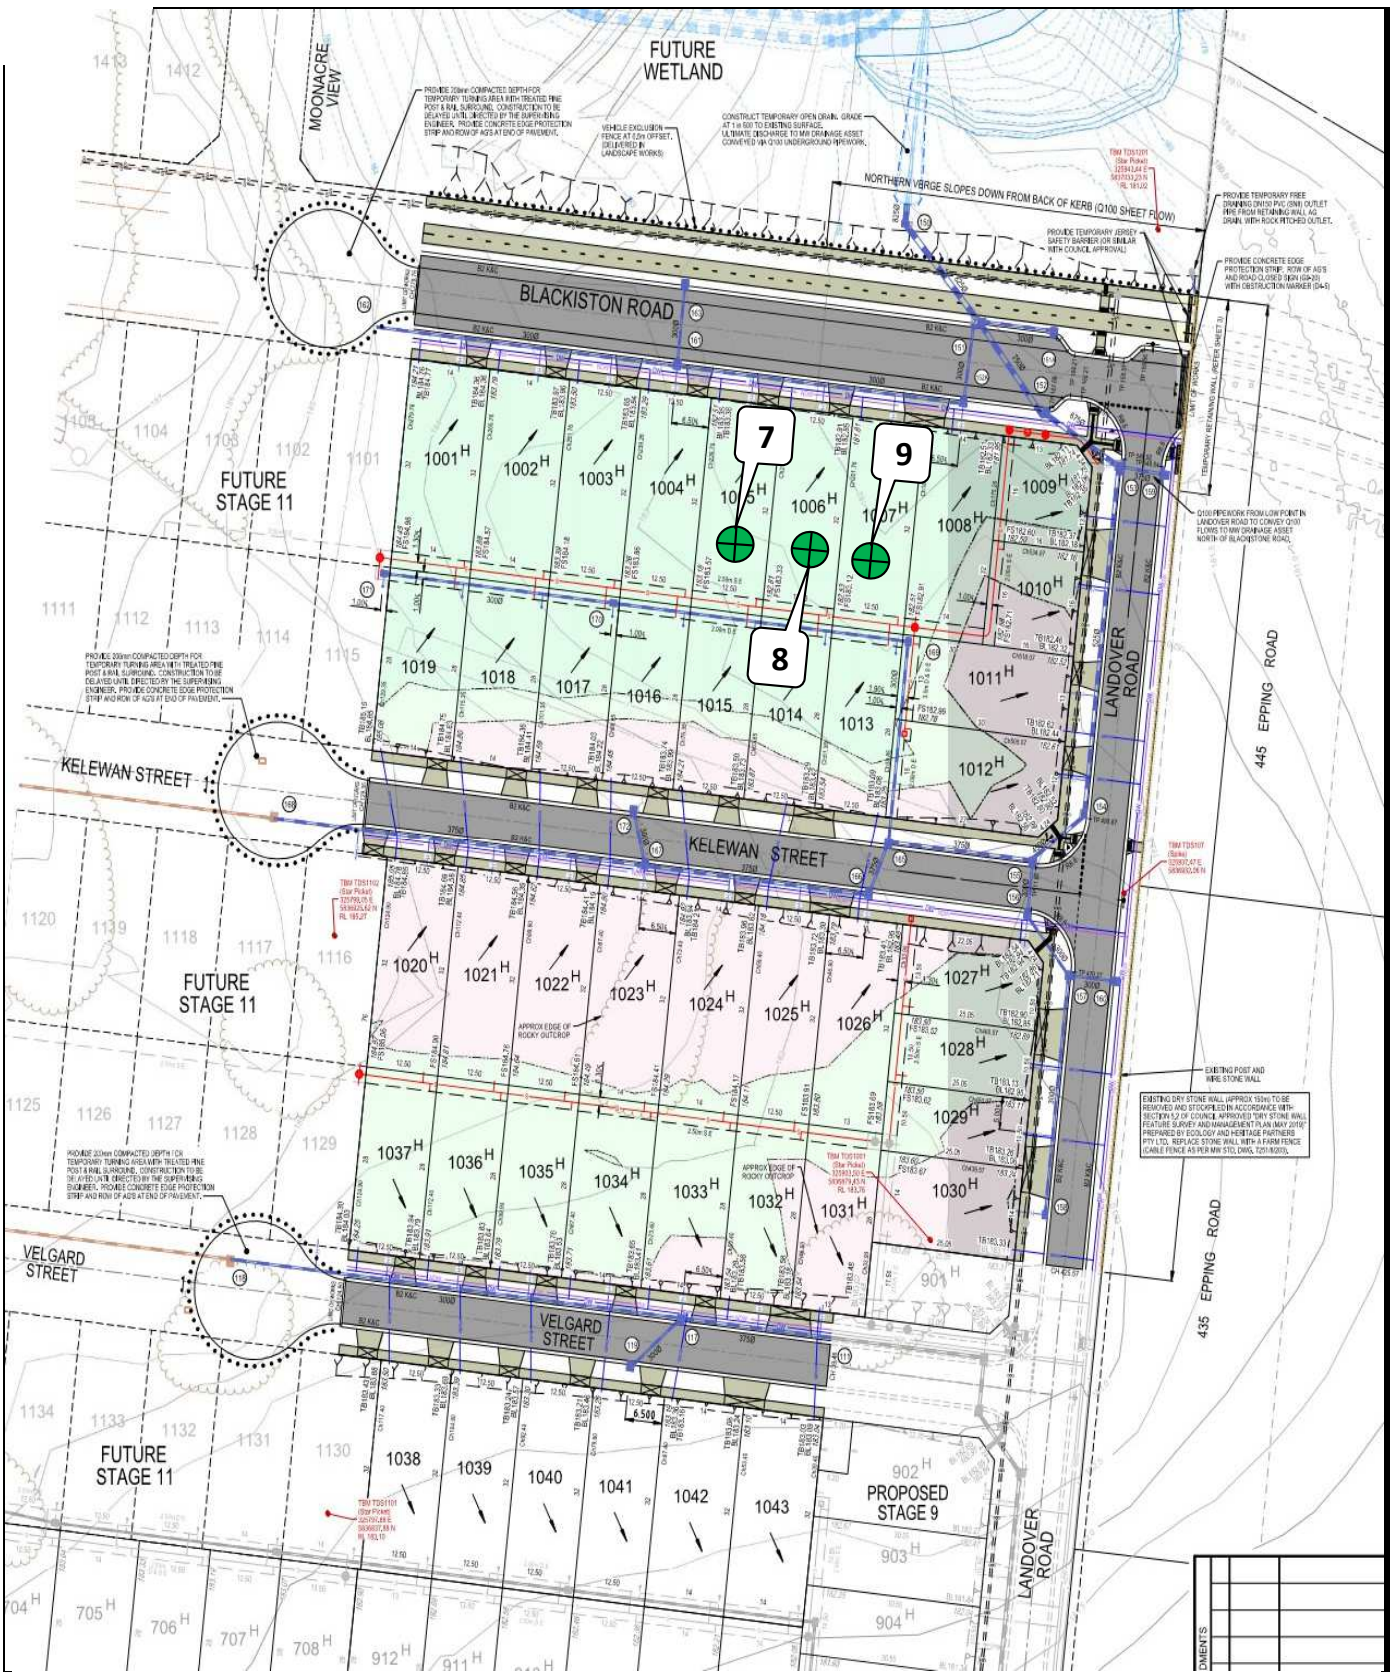
**JOB No.: 9189/011**  
**CHECKED: KK**  
**FIGURE No: -**

**CLIENT: SYMON BROS**  
**LOCATION: Ellery Estate, Stage 10**  
**Sketch indicating compaction test locations**

**DATE: 7/06/2024**  
**OPERATOR: FH**  
**SCALE: NTS**

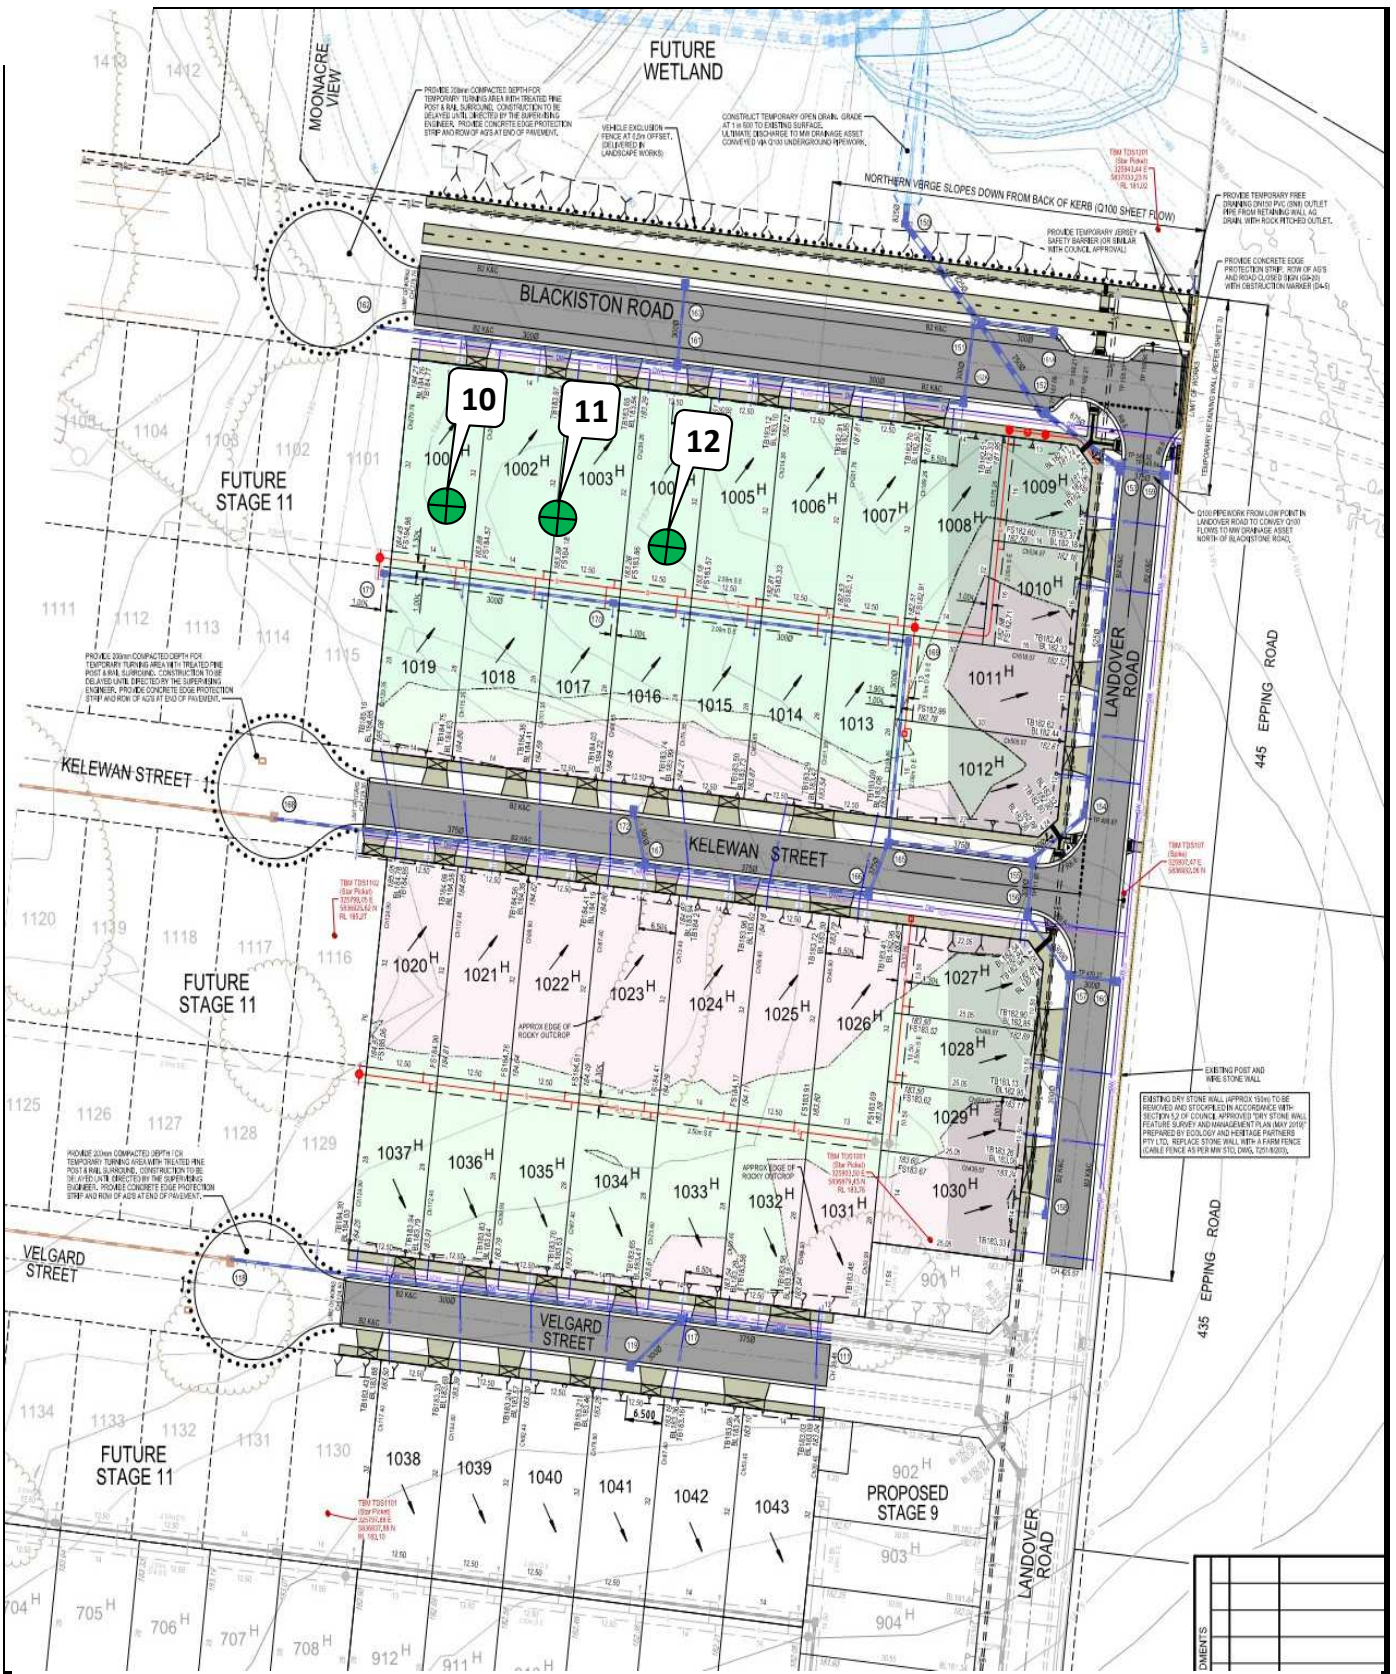
**JOB No.: 9189/015**

**Sketch indicating compaction test locations**

**DATE: 17/06/2024**

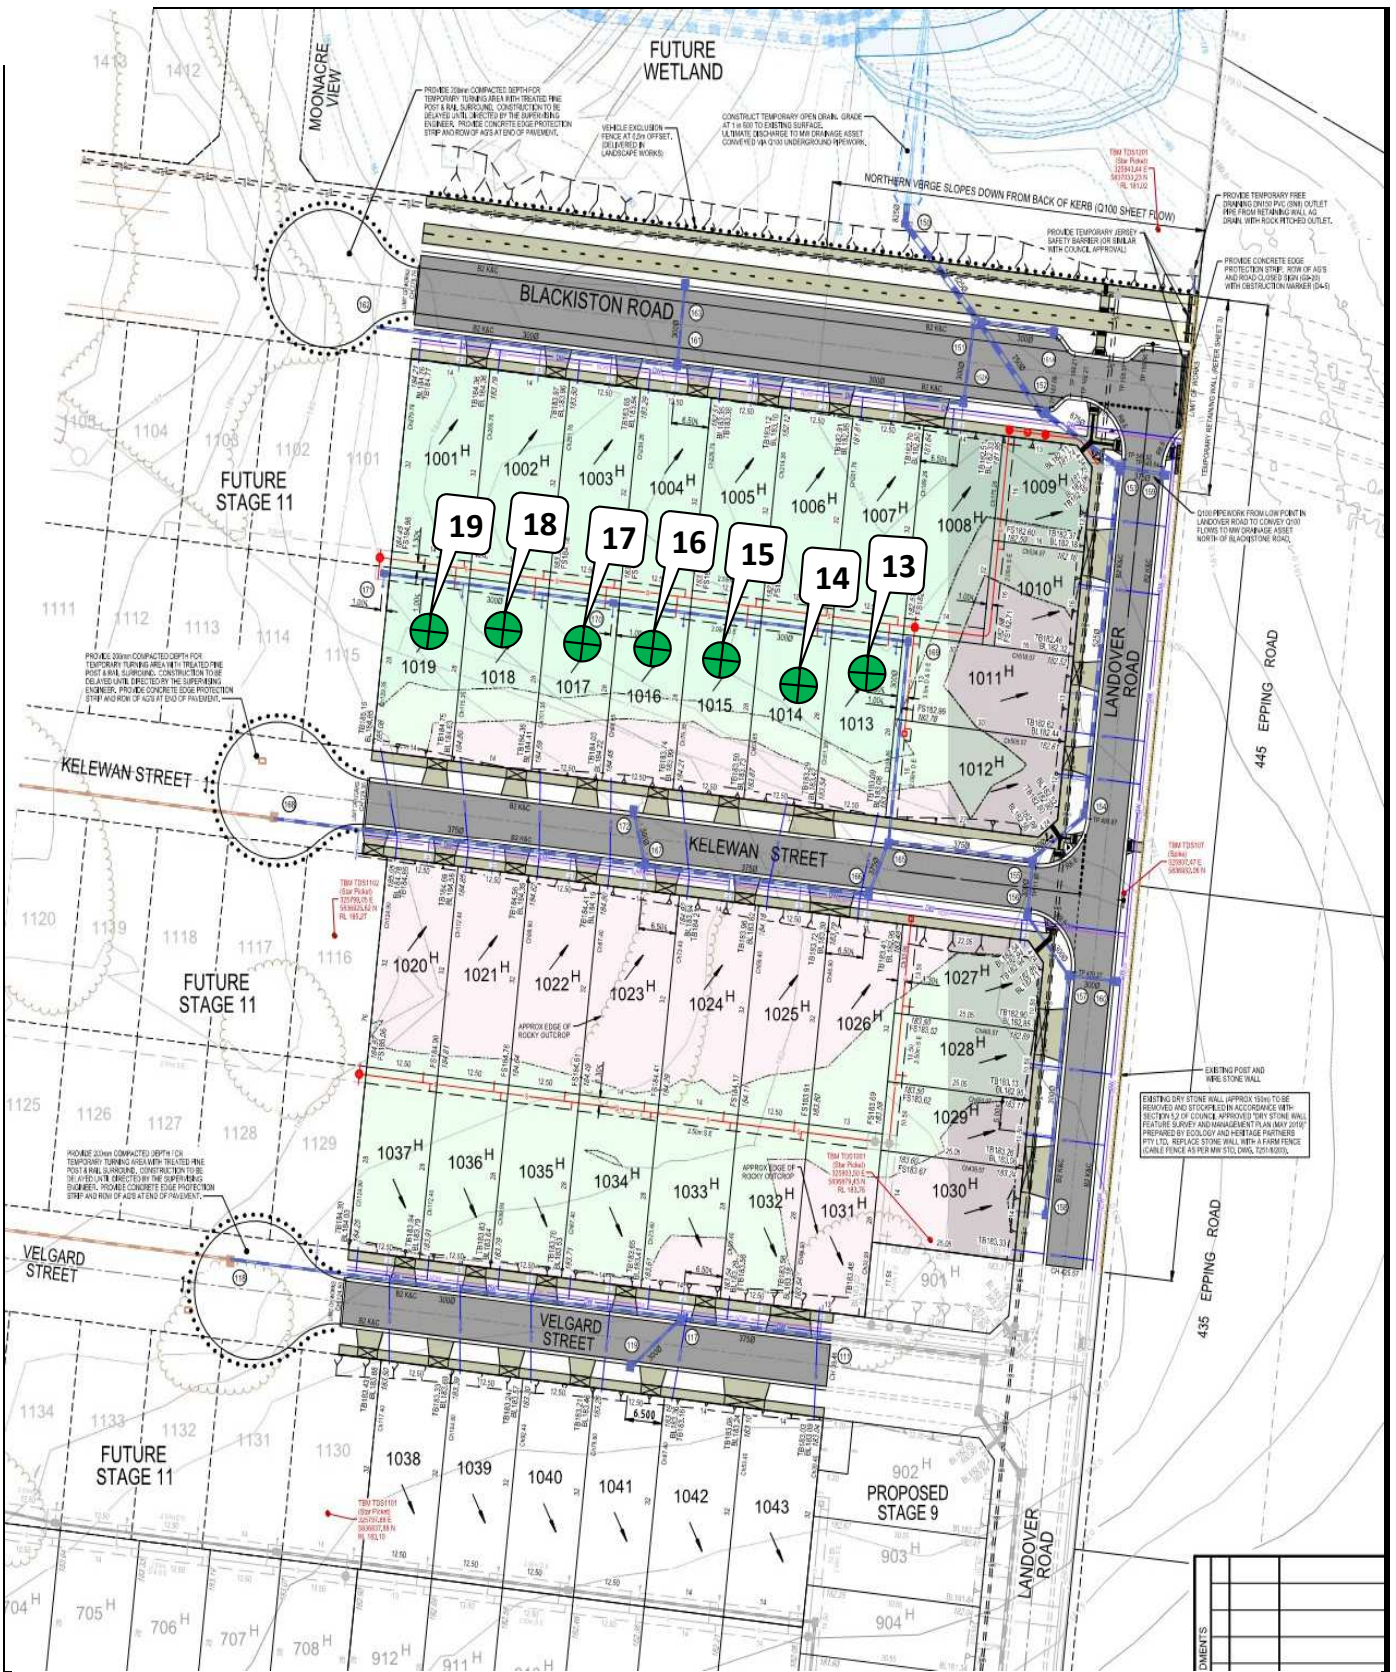
<b>CLIENT: SYMON BROS</b>	<b>DATE: 18/06/2024</b>	<b>JOB No.: 9189/018</b>
<b>LOCATION: Ellery Estate, Stage 10</b>	<b>OPERATOR: FH</b>	<b>CHECKED: NF</b>
<b>Sketch indicating compaction test locations</b>	<b>SCALE: NTS</b>	<b>FIGURE No: -</b>

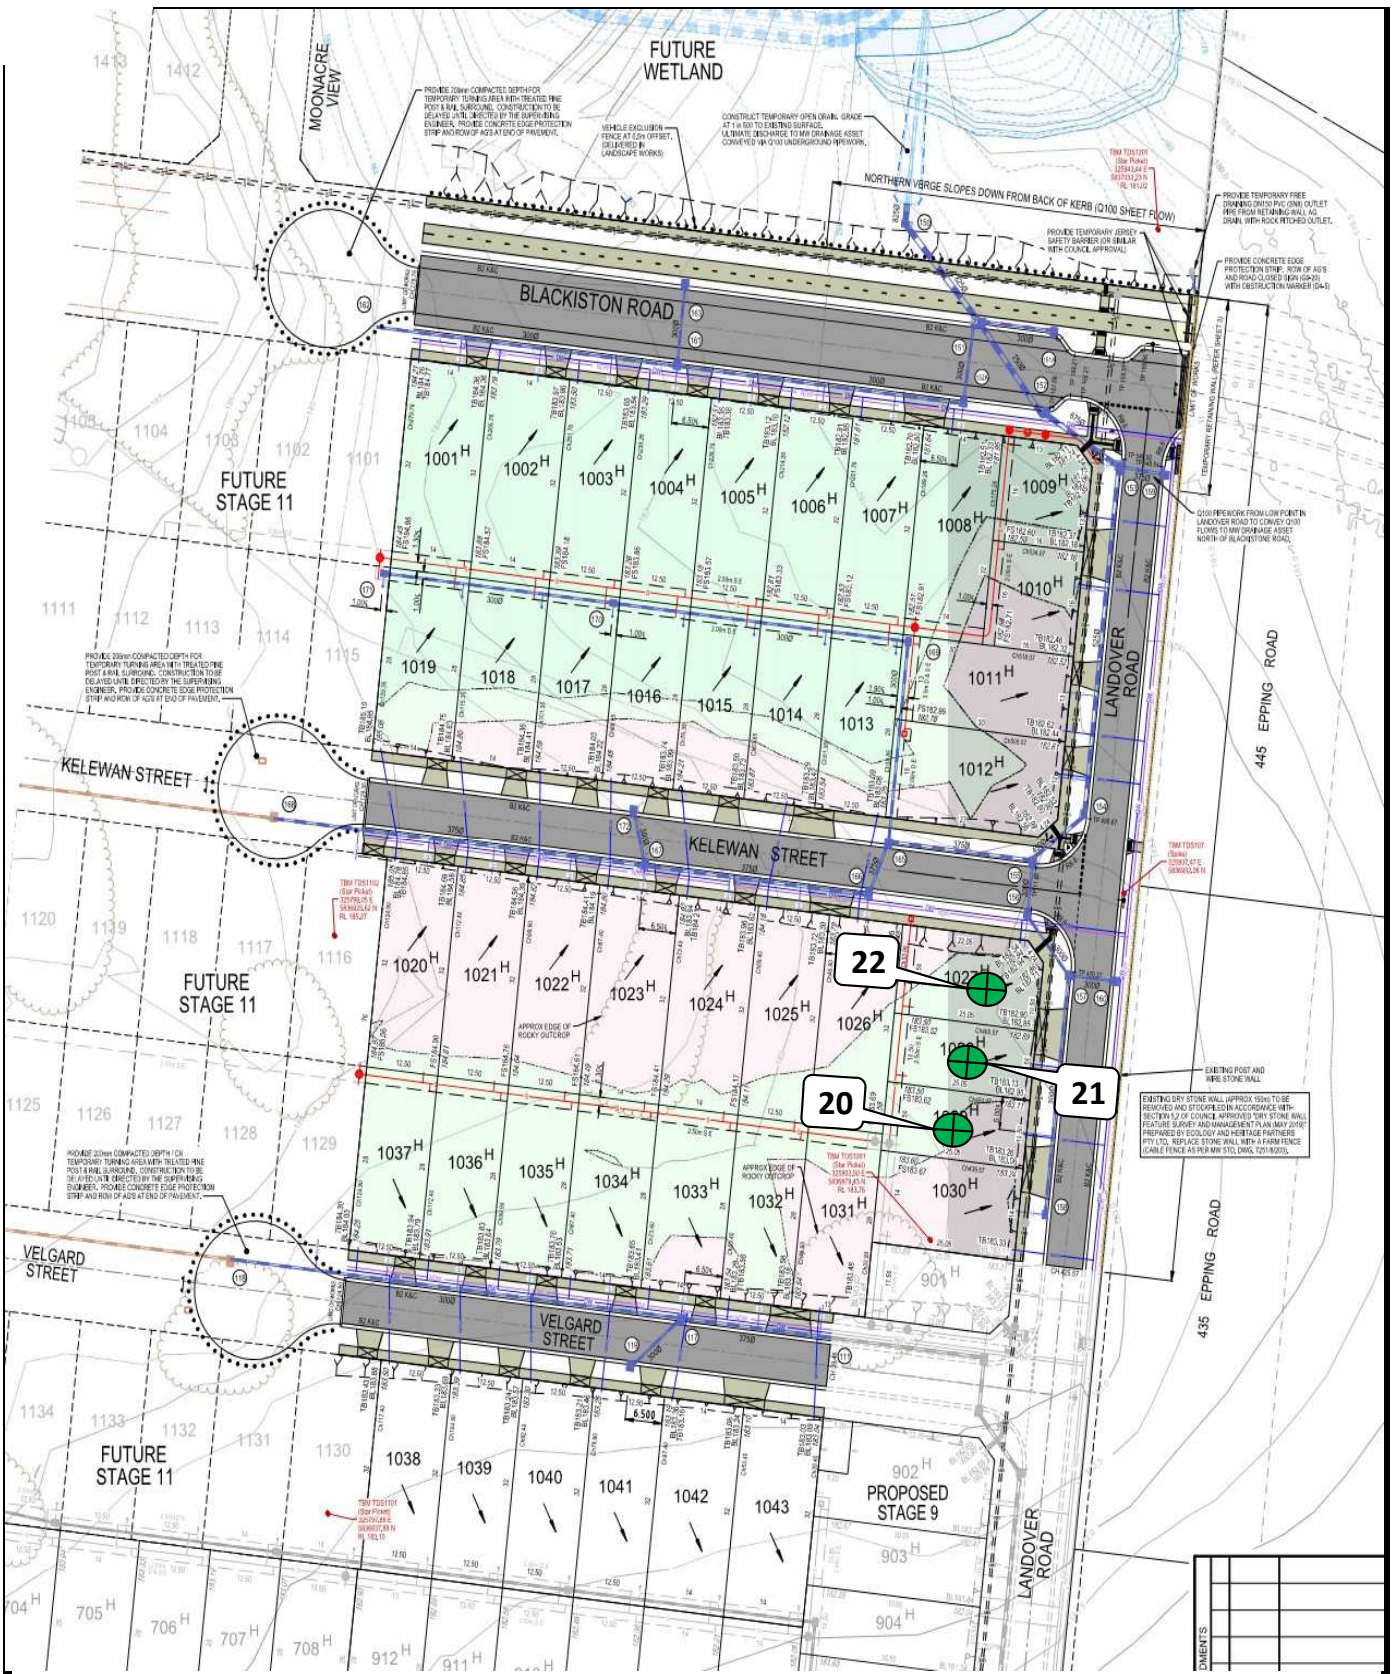
**JOB No.: 9189/020**

**Sketch indicating compaction test locations**

**DATE: 22/08/2024**

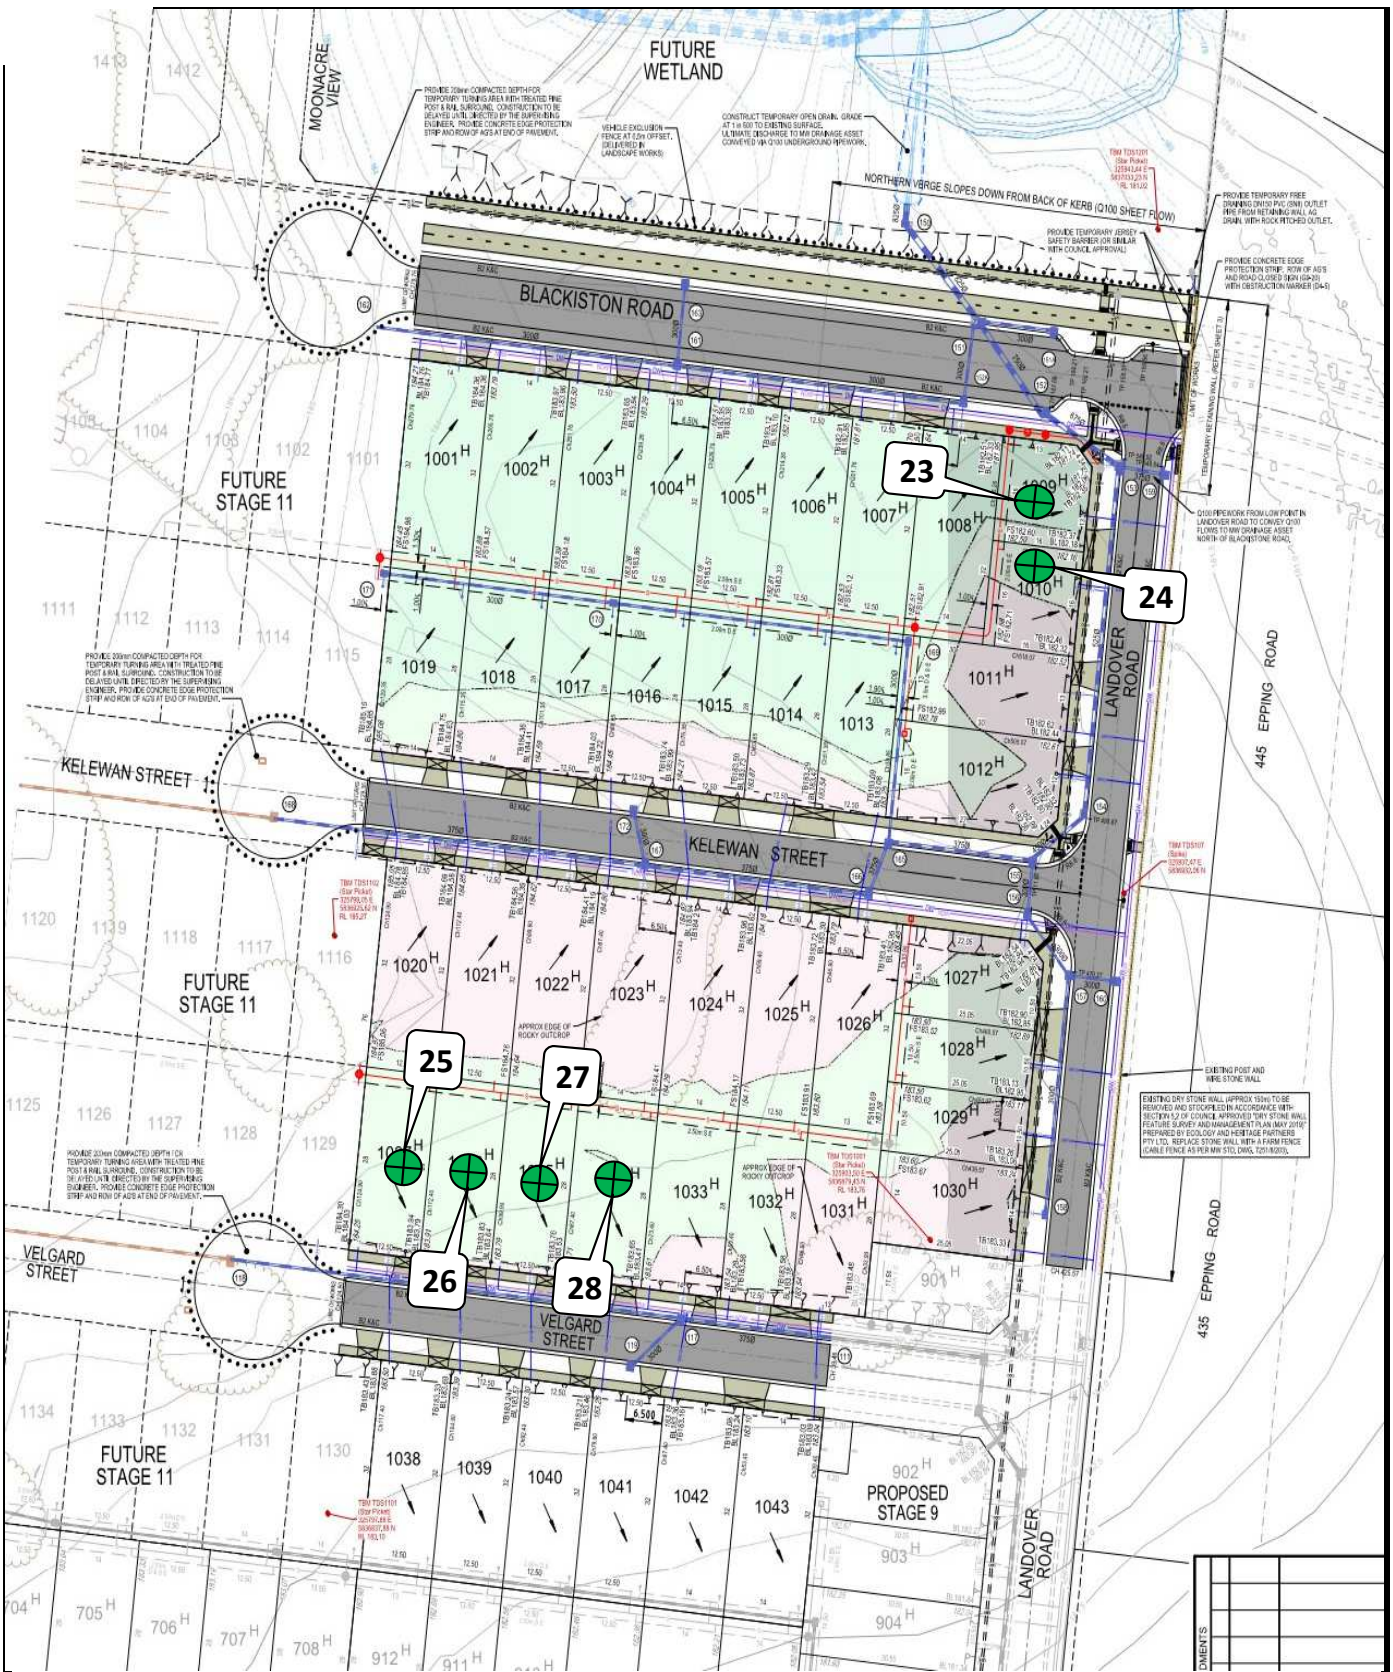
<b>CLIENT: SYMON BROS</b>	<b>DATE: 23/08/2024</b>	<b>JOB No.: 9189/023</b>
<b>LOCATION: Ellery Estate, Stage 10</b>	<b>OPERATOR: SG</b>	<b>CHECKED: KK</b>
<b>Sketch indicating compaction test locations</b>	<b>SCALE: NTS</b>	<b>FIGURE No: -</b>
