## Level 1 Report – AS3798

**Client: CCA Winslow**  
**Project: Riverbank Stage 21, Caboolture Qld 4510**  
**Job No: J23/52**  
**Docket No: 53410**  
**Developer: PEET**  
**Consulting Engineer: Urban Engineering Solutions**

Wagner Soil Testing has recently completed a Level One Overview of Earthworks, in accordance with the requirements of AS3798 – “Guidelines on Earthworks for Commercial and Residential Developments” for Pine Street, Caboolture Qld 4510.

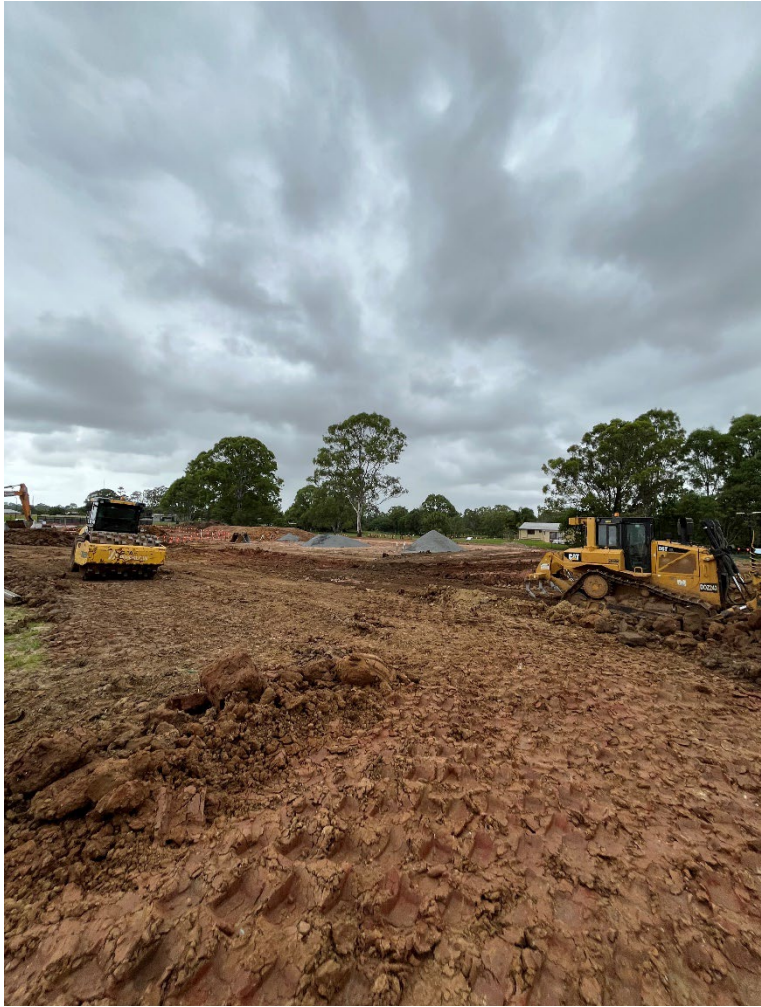
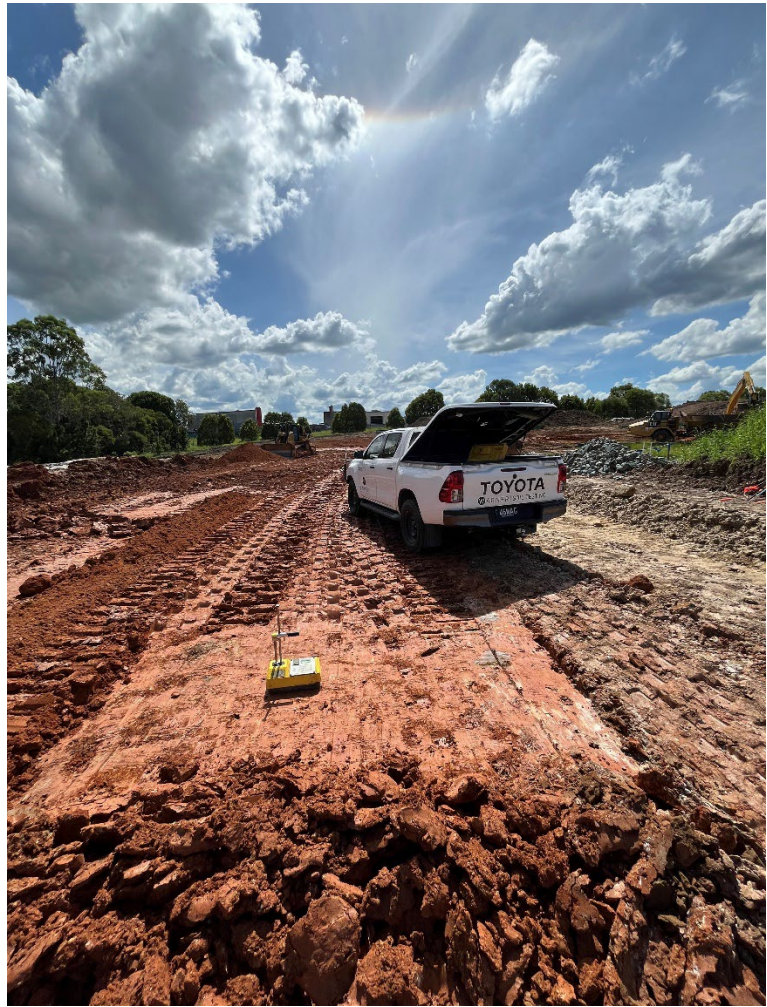
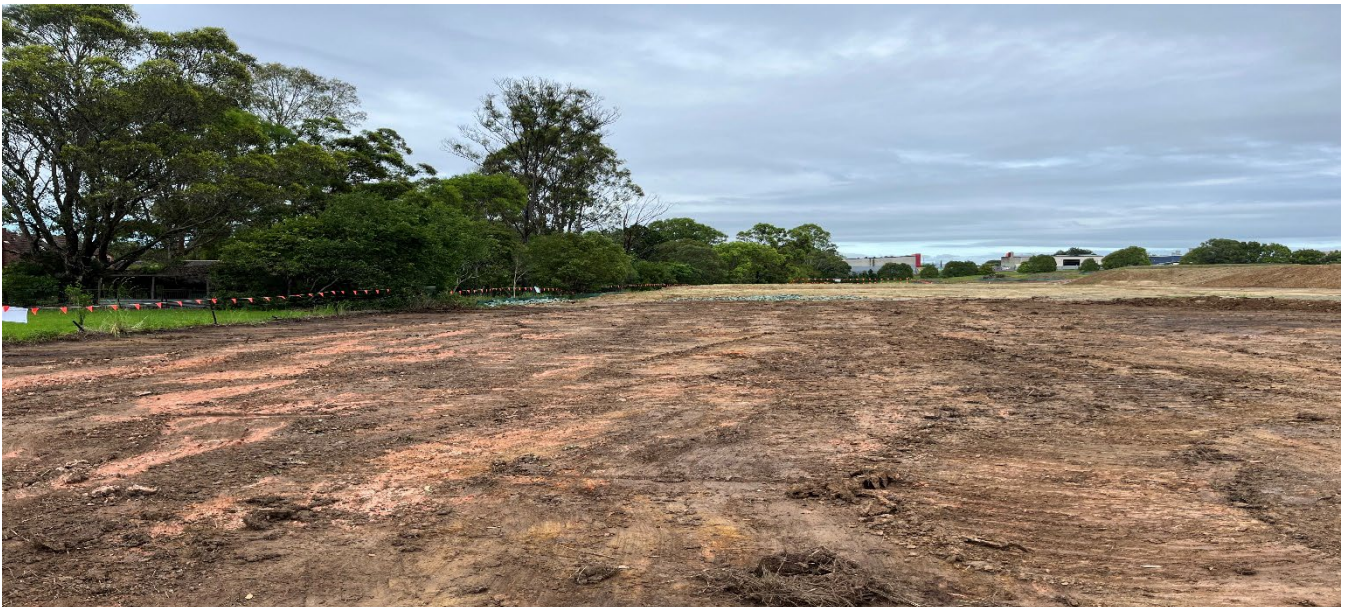
## Appendix 3: Typical Site Conditions

Fill materials (on-site) were compacted using a medium sized pad foot roller in layers not exceeding 0.3m loose. The natural ground in the areas of filling generally comprised of Silty Clay (CH). The fill material used was generally as above. Moisture contents of all fill material placed was monitored by Wagner Soil Testing. Total volumes of fill reached 8593m<sup>3</sup>.
